HOME LAND

ENVIRONMENTAL

Date: September 1, 2022 Name of Evaluator: Scott Thompson Time: 08:00 Property Address: 9011 Old Court Road Windsor Mill, MD. 21244 Recent Weather Conditions: Rain	Ordered By: Cherly Parker Buyers: Cherly Parker Homeowner Interview: The homeowner interview was sent but not received prior to the evaluation.	Occupied: <input checked="" type="checkbox"/> Yes <input type="checkbox"/> No Length of Time Vacant: N/A # of People Living in Home: Unknown # of People moving in: Unknown Property Age: 1967 System Age: 1967; 2013 Last Date of Cleaning: Unknown Recomm'd Pumping Freq: 2-3 Years
Liquid level in tank is: <input type="checkbox"/> Above Normal <input checked="" type="checkbox"/> Normal <input type="checkbox"/> Below Normal	Bottom Solids Depth: 22 & 10 Inches	
Depth of tank: 13 & 23 Inches	Type of Tank Access: Manhole Risers (3)	Depth of tank access: At Grade
Maintenance appears: <input type="checkbox"/> Good <input checked="" type="checkbox"/> Fair <input type="checkbox"/> Poor	Depth to Distribution Box: ~18 Inches

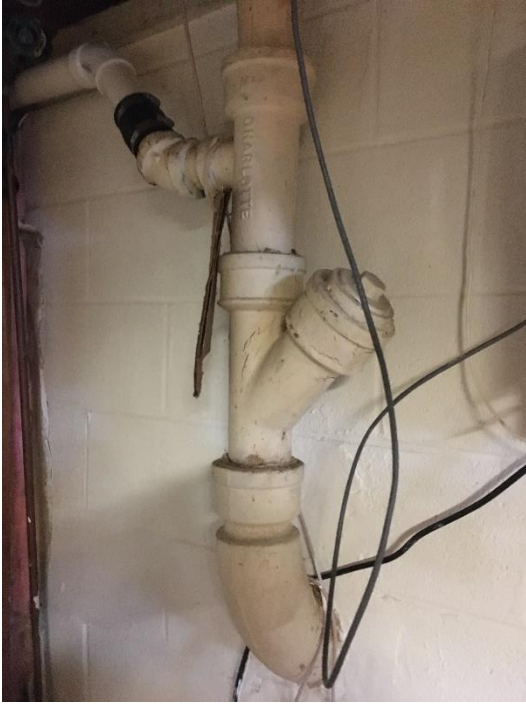
Picture 1:

Shows the limited access within the original structure. The cap is painted and sealed shut.

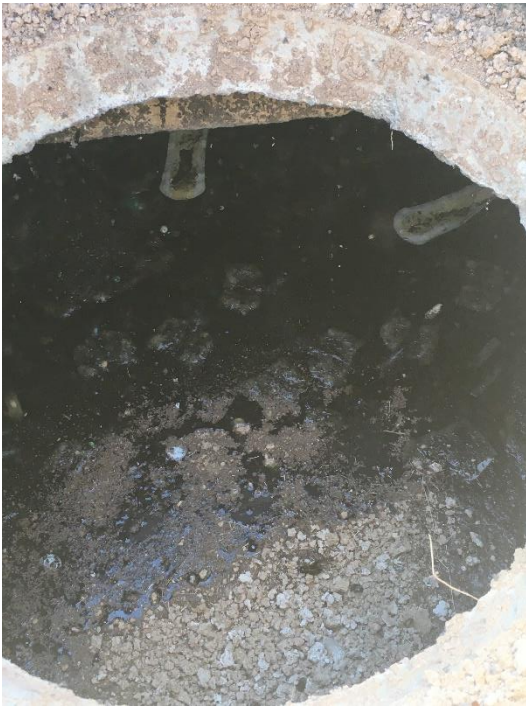
Picture 2:

Shows the foreign objects in the tank.
