CHAVIS SEPTIC SERVICES

MDE ONSITE SEWAGE DISPOSAL SYSTEM (OSDS) OPERATING INSPECTION FORM

The septic system located at 19701 Old York Road in White Hall, Maryland 21161 was inspected on Thursday August 10th, 2023 at approximately 12:00 PM. The current septic tank is constructed from cinder blocks. Access to the septic tank was through a manhole riser installed to grade. The lid of the manhole riser was found cracked and broken. Due to the fact that the septic tank is constructed from cinder blocks it is considered unacceptable due to its age, likelihood of not being water tight and its structural integrity. The cinder block tank will need to be pumped and abandoned. A pre-cast concrete top seam septic tank will need to be installed by a licensed septic contractor. We were able to locate 2 dry wells at the time of the inspection. Each of the dry wells are hooked in a serial connection. The first dry well in the connection was found to be 6' in depth with a diameter of 6'. There was currently 32" of operating room remaining inside of the dry well before the effluent will begin to flow to the second dry well. The second dry well in the connection was found to be 8' in depth with a d

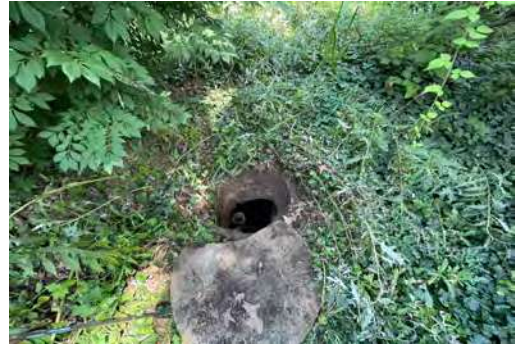
Cinder Block Tank Access

Was Septic Tank Located?		Yes			
If Pre-Treatment Unit, Note Current Service Provider				N/A	
Describe Access to Septic Tank		Mahole Riser			
Depth of Tank Below Grade		12"			
Liquid Level in Tank (below normal/ normal/ above normal)				Normal	
Any Evidence of Elevated Levels of Sewage In the Past?				No	
Was Sludge Sample Collected?		No			
If Yes, Total Liquid Depth		N/A	Sludge Depth		N/A
			Scum Depth		N/A
During Septic Tank Pump Out was any Flow Back Observed from Field System					Did not Pump
After Pump Out, Is Structural Integrity of the Tank Interior Acceptable?					No (Cinder Block Tank)
Presence of Inlet Baffle Verified and Condition Acceptable?				Yes	
Presence of Outlet Baffle Verified and Condition Acceptable?				Yes	
<u>Septic Tank Observations:</u> <p>The current septic tank is constructed from cinder blocks. Access to the septic tank was through a manhole riser installed to grade. The lid of the manhole riser was found cracked and broken. Due to the fact that the septic tank is constructed from cinder blocks it is considered unacceptable due to its age, likelihood of not being water tight and its structural integrity. The cinder block tank will need to be pumped and abandoned. A pre-cast concrete top seam septic tank will need to be installed by a licensed septic contractor.</p> <p>Overall Condition of Septic Tank: Unacceptable</p>

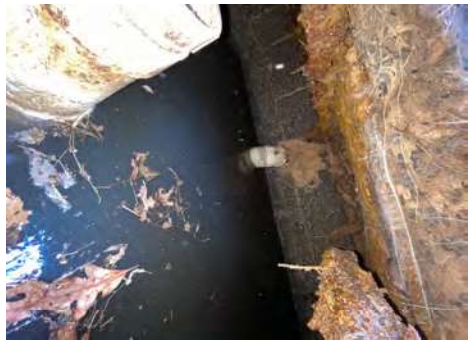
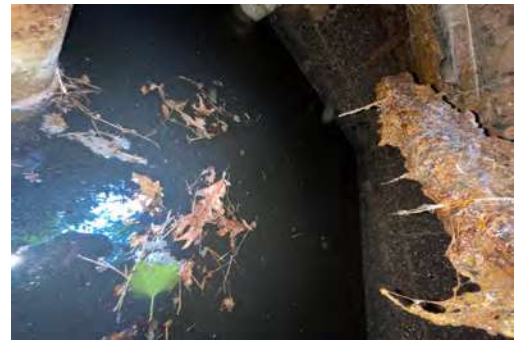
Inside of Cinder Block Tank

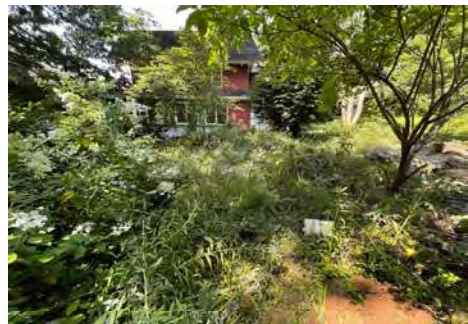
First Dry Well in Series Location

Was Distribution Box Located?	No (Serial Connection)						
Method of Locating Distribution Box	N/A						
Does the Distribution of Effluent Appear to be Equal?	Serial Connection						
Was Soil Absorption System Located?	Yes						
Are Observation Ports Present/ Functional?	Yes						
Was Hydraulic Load Test Performed?	Yes						
If Yes, Volume of Water Introduced to System	50 Gallons						
<u>Soil Absorption System Observations:</u> <p>We were able to located 2 dry wells at the time of the inspection. Each of the dry wells are hooked in a serial connection. The first dry well in the connection was found to be 6' in depth with a diameter of 6'. There was currently 32" of operating room remaining inside of the dry well before the effluent will begin to flow to the second dry well. The second dry well in the connection was found to be 8' in depth with a diameter of 8'. The second dry well was found to be completely dry. A very small hydraulic load test was completed and confirmed that the effluent was making it from the septic tank to the first dry well but since the wastewater level is still below the effluent line leaving the first dry well we could not confirm that the effluent would flow from the first dry well to the second dry well.</p> <p>Overall Condition of Soil Absorption System: Acceptable</p>
