MDE ONSITE SEWAGE DISPOSAL SYSTEM (OSDS) OPERATING INSPECTION FORM

Client Information																		
Name Jenniger Staab						Phone Number 443-8				3-86	-865-5021							
Street Addı	Street Address 2429 Harkins Road						Ema	Email staabtr			truc	ruckingllc@gmail.com						
City White Hall						Stat	State MD			Zip Code 21161								
					(Genera	l Info	rn	ation	ì								
Property Address 19701 Old York Road																		
City White Hall							Stat	State MD Zip Code						21161				
County Baltimore							Date	Date and Time of Inspection 08/09/2023 12:00							00 PM			
Inspector N	Inspector Name Heath Vinck						Con	Company Chavis Septic Services										
Office Pho	Office Phone 410-838-1200						Fax Number 410-838-3001											
Mobile Pho	Mobile Phone 410-940-9377						Ema	Email heath@chavisenterprisesllc.com										
Property T	perty Type Residential				Age	of Dwe	lling	ling 83 Years Number of				of F	Bedrooms		3			
Occupied?	cupied? No If Vacant						w Lor	Long? Unknown Rental?						No	No

Inspection Summary

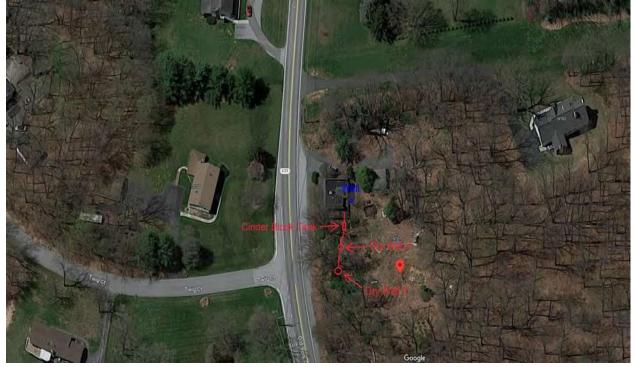
OSDS Layout

Show a diagram of the OSDS layout relative to the house. Include well location, street location, driveway and other pertinent site features as well as all OSDS piping and components.
