HOMELAND ENVIRONMENTAL

<p>Date: 8/2/2024 Name of Evaluator: Drew Henderson Time: 08:00 Property Address: 2304 Stockton Road Joppa, MD 21085 Recent Weather Conditions: Normal</p>	<p>Ordered By: Marinos Gialames</p> <p>Homeowner Interview: The homeowner interview was conducted during the evaluation.</p>	<p>Occupied: <input type="checkbox"/> Yes <input checked="" type="checkbox"/> No Length of Time Vacant: Unknown # of People Living in Home: N/A # of People moving in: 4 Property Age: 1959 System Age: 2012 & Unknown Last Date of Cleaning: -1 month ago Recomm'd Pumping Freq: 2-3 Years</p>
Liquid level in tank is: <input type="checkbox"/> Above Normal <input checked="" type="checkbox"/> Normal <input type="checkbox"/> Below Normal		Bottom Solids Depth: 0 Inches
Depth of tank: 14 Inches	Type of Tank Access: Risers	Depth of tank access: At Grade
Maintenance appears: <input checked="" type="checkbox"/> Good <input type="checkbox"/> Fair <input type="checkbox"/> Poor		# of Bedrooms: 3

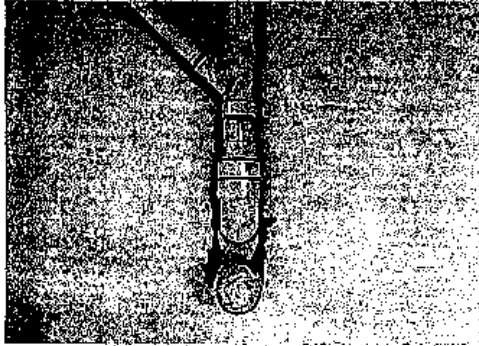
Picture 1:

Showing the sewer line leaving the side of the house in the unfinished basement

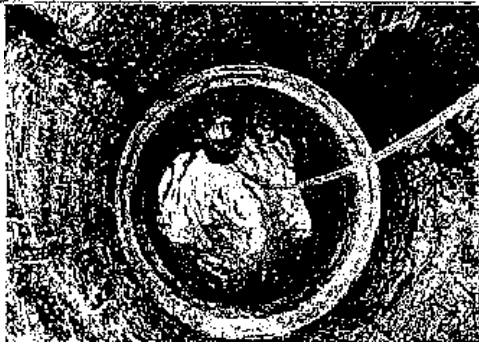
Picture 2:

Showing inside the back of the septic tank.

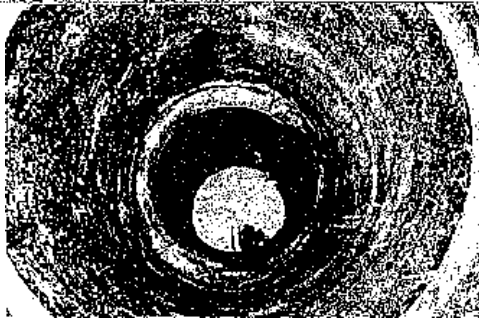
Picture 3:

Showing inside the front chamber of the septic tank

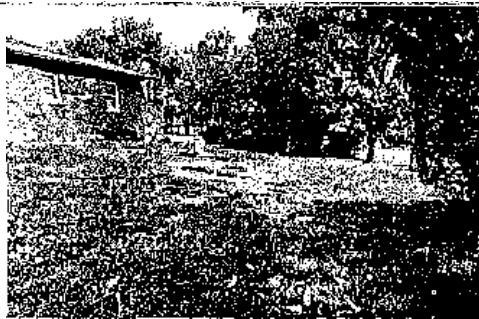
Picture 4:

Showing location of the drainfields

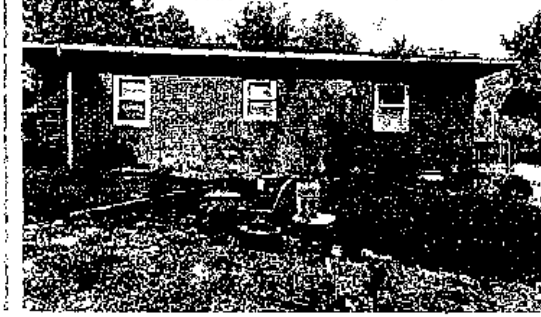
Picture 5:

Showing the location of the septic tank
