# HOME LAND

## ENVIRONMENTAL

Location	Inspector
521 Dutrow Road Westminster MD 21157	Nicholas Riehl Environmental Inspector

Friday, December 13, 2024

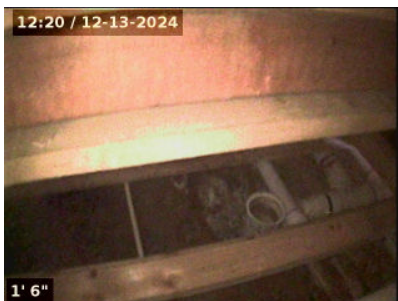
1' 6"

Access to the sewer

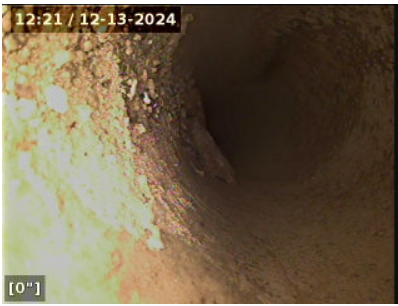
0"

Start of the front line.

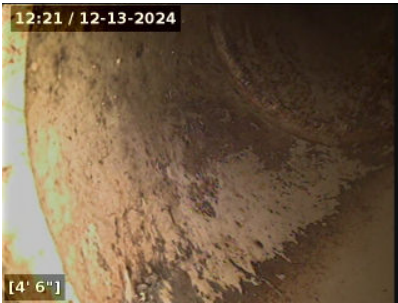
4' 6"

Bend in the line.

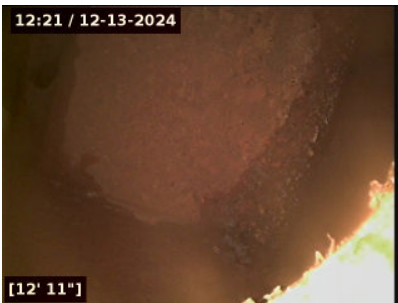
12' 11"

End of the line. The camera has reached the septic tank.
