HOME LAND

ENVIRONMENTAL

Date: December 13, 2024 Name of Evaluator: Nicholas Riehl Time: 11:45 AM Property Address: 521 Dutrow Road Westminster, MD 21157 Recent Weather Conditions: Normal		Ordered By: Robert Shaffer Buyers: Robert Shaffer Homeowner Interview: The homeowner interview was sent and was received prior to the evaluation.		Occupied: <input type="checkbox"/> Yes <input checked="" type="checkbox"/> No Length of Time Vacant: 5+ years # of People Living in Home: N/A # of People moving in: Unknown Property Age: 1920 System Age: Unknown Last Date of Cleaning: Unknown Recomm'd Pumping Freq: 2-3 years	
Liquid level in tank is: <input type="checkbox"/> Above Normal <input checked="" type="checkbox"/> Normal <input type="checkbox"/> Below Normal				Bottom Solids Depth: Unknown	
Depth of tank: ~25 Inches		Type of Tank Access: Cleanout		Depth of tank access: At Grade	
Maintenance appears: <input type="checkbox"/> Good <input checked="" type="checkbox"/> Fair <input type="checkbox"/> Poor		# of Bedrooms: 3*		Depth to Distribution Box: ?

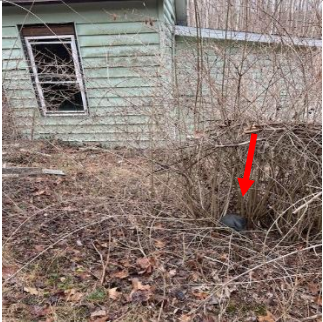
<p>Picture 1:</p> <p>This shows the septic tank in relation to the house.</p>

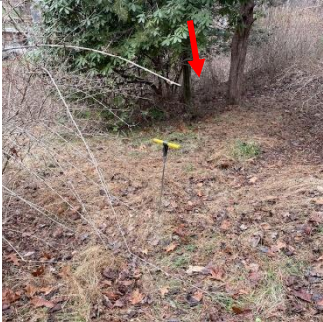
<p>Picture 2:</p> <p>This shows the believed absorption system in relation to the tank.</p>
<p>No Picture</p>		<p>Picture 3:</p> <p>This space was intentionally left blank</p>
<p>No Picture</p>		<p>Picture 4:</p> <p>This space was intentionally left blank.</p>
