# HOME LAND

| <b>Date:</b> June 1, 2026<br><b>Name of Evaluator:</b> Jon Blevins<br><b>Time:</b> 8:00<br><b>Property Address:</b><br>12 Gunpowder Road<br>Glen Arm, MD 21057<br><b>Recent Weather Conditions:</b> Normal | | <b>Ordered By:</b> Seth Henchers<br><b>Buyers:</b> Tom Reynolds<br><b>Homeowner Interview:</b> The homeowner interview was sent but not received prior to the evaluation. | | <b>Occupied:</b> <input type="checkbox"/> Yes <input checked="" type="checkbox"/> No<br><b>Length of Time Vacant:</b> ~8 years<br><b># of People Living in Home:</b> 0<br><b># of People moving in:</b> Unknown<br><b>Property Age:</b> 1952<br><b>System Age:</b> 1952, *1993<br><b>Last Date of Cleaning:</b> Unknown<br><b>Recom'd Pumping Freq:</b> 2-3 Years | |

### Baltimore County Well Yield Report

Camera septic inspection for the purpose of a real estate transaction. Refer to Septic Evaluation for more information.

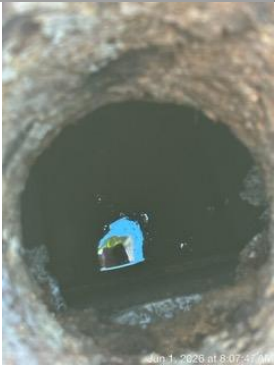
**Picture 1:**

| <b>Septic Tank</b> | | <input type="checkbox"/> Acceptable<br><input checked="" type="checkbox"/> Unacceptable<br><input type="checkbox"/> Needs Further Evaluation | | A SeeSnake camera was used during the inspection (Refer to Camera Inspection). The concrete septic tank appears to be 1,000 gallons in capacity. Six-inch metal cleanouts serve as access at grade at both ends with no caps; the septic tank is 24 inches below grade. Both front and back baffles are in place and composed of concrete. The liquid level in the tank was at the mid-seam upon arrival, suggesting the tank is not watertight. An attempt to fill the tank to its normal level was made, with the level never reaching the outlet line, and then dropping by at least 8 inches during the inspection. A licensed septic contractor must be contacted to replace the septic tank after permits are pulled. | |

Showing the low liquid level in the septic tank upon arrival. When water was added to the tank, the liquid level never reached the outlet line, and then receded back to its below normal mid-seam level during the inspection, confirming that the tank is leaking from the mid-seam.

Explain: The septic tank is not watertight and must be replaced. The distribution box is corroded and must be replaced.

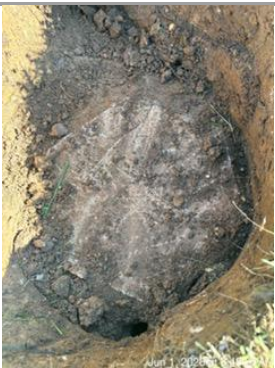
**Picture 2:**

Showing the lid of the distribution box. The lid is corroded and will fall apart if opened.

Comments: The distribution box lid is too corroded to open without it falling apart. The distribution box must be replaced when the tank is replaced.

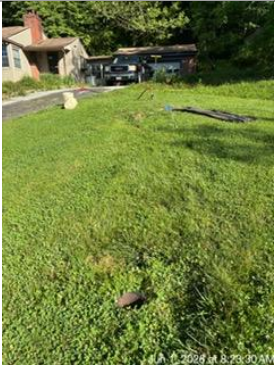
**Picture 3:**

Showing drywell A in relation to the house.

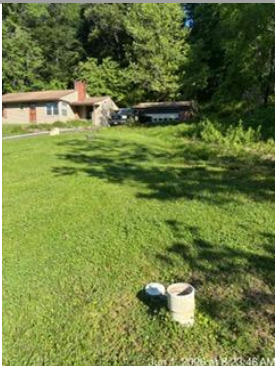
**Picture 4:**

Showing drywell B in relation to the house.

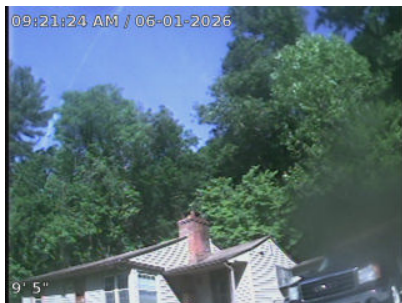
9' 5"

Start of video. Entry point septic tank front line toward house. Showing front of house.

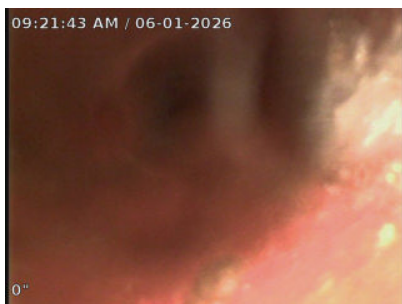
0"

Beginning of terracotta front line. Slight left bend.

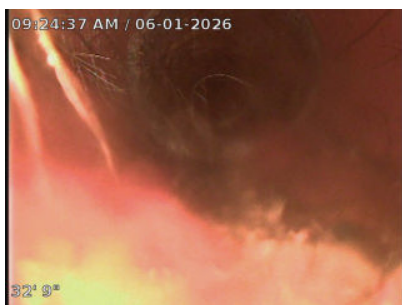
32' 10"

Change in line from terracotta to cast-iron.

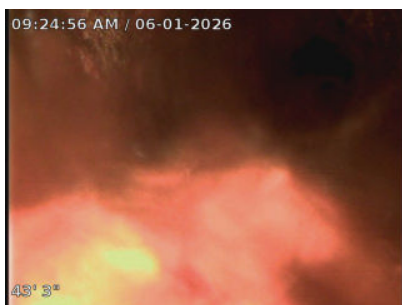
43' 3"

End of front line inside house.

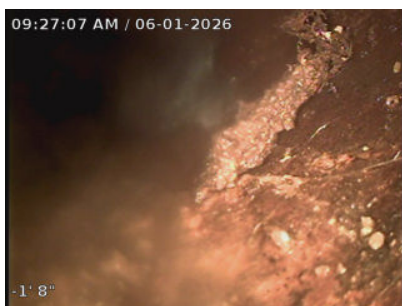
-1' 8"

Camera removed from front line.

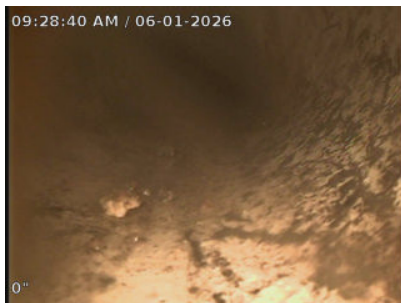
0"

Entry point septic tank back line toward distribution box. Beginning of PVC back line.

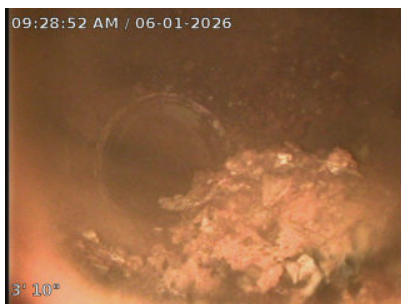
3' 10"

End of back line inside distribution box.

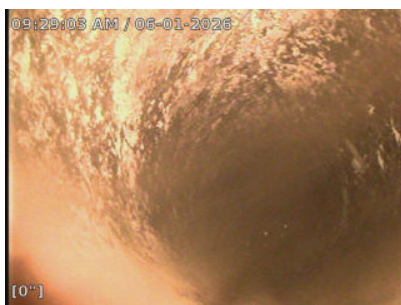
0"

Start of absorption system. Entry point distribution box to PVC line to drywell A.

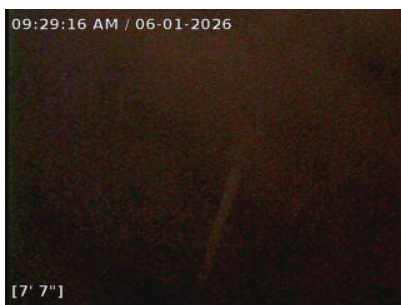
7' 7"

End of line inside drywell A.

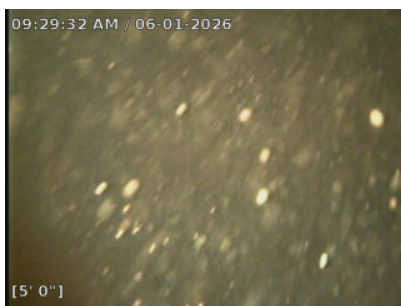
5' 0"

Camera lowered to liquid level in drywell A. The drywell has approximately 5 feet of liquid depth remaining.

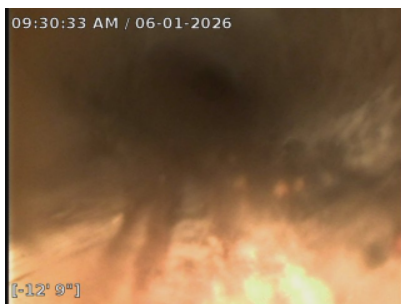
-12' 9"

Camera removed from drywell A and back line. End of inspection.
