### Baltimore County Well Yield Report

4 Country Hill Court, Kingsville, MD. 21087

# Maryland On-Site Sewage Disposal System Inspection Report

Address: 4 Country Hill Court

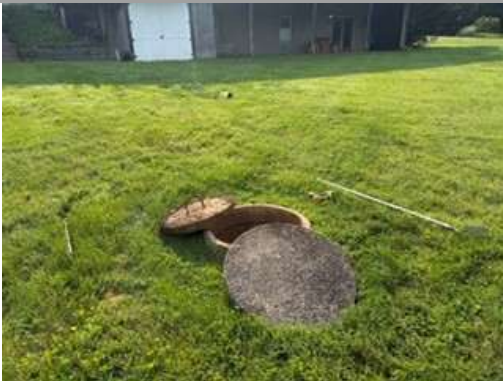
**Picture 1:**

This picture shows the location of the septic tank.

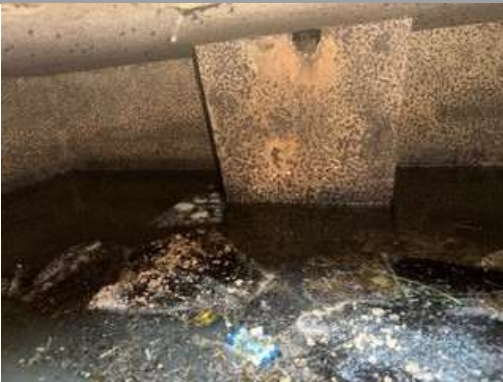
**Picture 2:**

This picture shows the concrete back baffle, as well as the foreign objects in the tank.

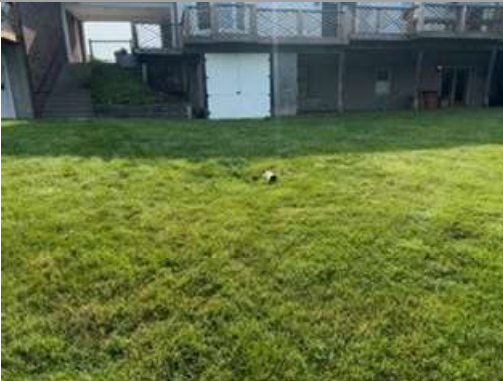
**Picture 3:**

| Septic Tank | | <input checked="" type="checkbox"/> Acceptable<br><input type="checkbox"/> Unacceptable<br><input type="checkbox"/> Needs Further Evaluation | | The septic tank is composed of concrete and has a capacity of approximately 1,500 gallons. Access consists of a riser above grade over the center of the tank; the tank is 13" below grade. The top riser ring was found to be cracked; the condition should be monitored. The front and back baffles are in place and composed of concrete. There are currently 18" of solids as well as foreign objects in the tank, indicating the tank is due to be cleaned. A broken snake line was located in the yard, however it could not be determined where/if this line is connected to the system. If this snake line is part of the septic system the pipe should be repaired by a licensed contractor. | |

This picture shows a broken snake line pipe in the yard. No connection to the front line was able to be located.

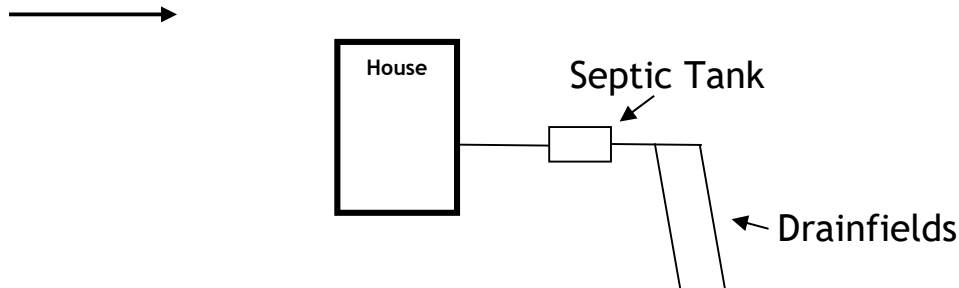
### Sketch of System

| Absorption System | | <input checked="" type="checkbox"/> Acceptable<br><input type="checkbox"/> Unacceptable<br><input type="checkbox"/> Needs Further Evaluation | | Two drainfields were located during the inspection. Both trenches were probed and found to be dry to a depth of at least 10" from the top of the stone. Approximately 300 gallons of water were introduced into the system with no signs of a back-up or surfacing to grade. | |
